# Picus Sonic Tomograph Test Report

## Beecroft Village shops carpark

Hornsby Shire Council, PO Box 37, Hornsby NSW 1630

February 2023

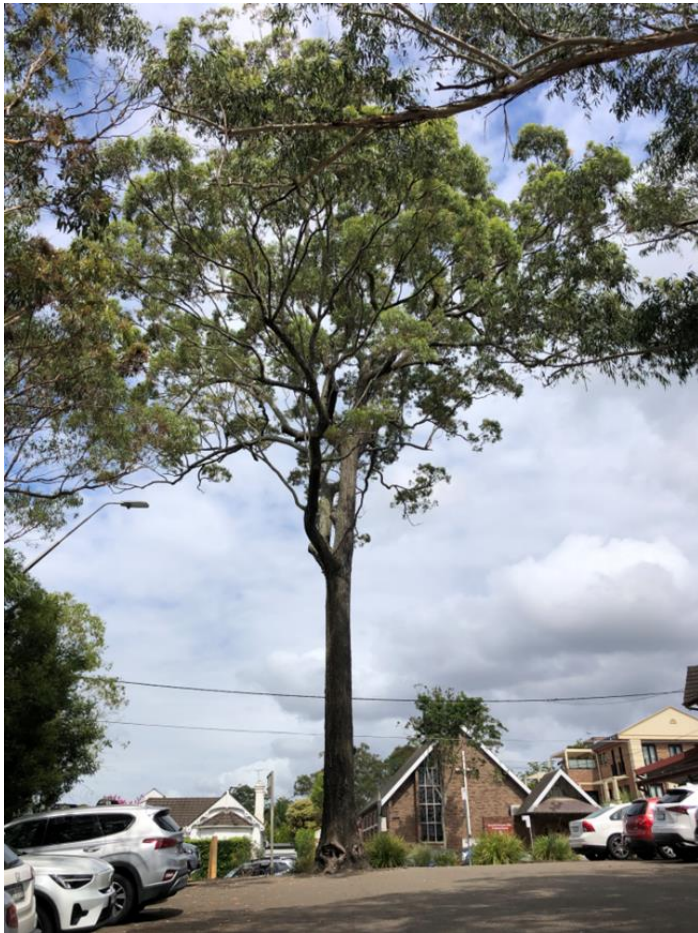
**Plate 1:** *The subject tree, Narrow-leaved Ironbark (*Eucalyptus crebra*). P. Vezgoff.*

The subject tree is located in a public car park associated with the Beecroft Village shops. The tree is one of two (2) large mature specimens growing within the car park area, within a cut out of asphalt. Although no fruit could be found, or flowers seen, the tree appears to be a Narrow-leaved Ironbark (*Eucalyptus crebra*). The tree is approximately nineteen (19) metres in height with a symmetrical spread of fifteen (15) metres. There is no deadwood greater than 20-30mm diameter within the canopy. There is a wound between sensors 9-11 and another smaller wound slightly above sensors 12 and 1. The wounding appears to have been happening over a number of years causing extensive cambial dieback. Wound wood is developing, however a decay pathogen has established within the wound as evidenced by the large fruiting body that is approximately one hundred and forty (140) millimetres wide between sensors 7 and 8. Another fruiting body is located on the south side of the trunk at approximately eleven (11) metres from ground level near a first order limb (Plate 3).

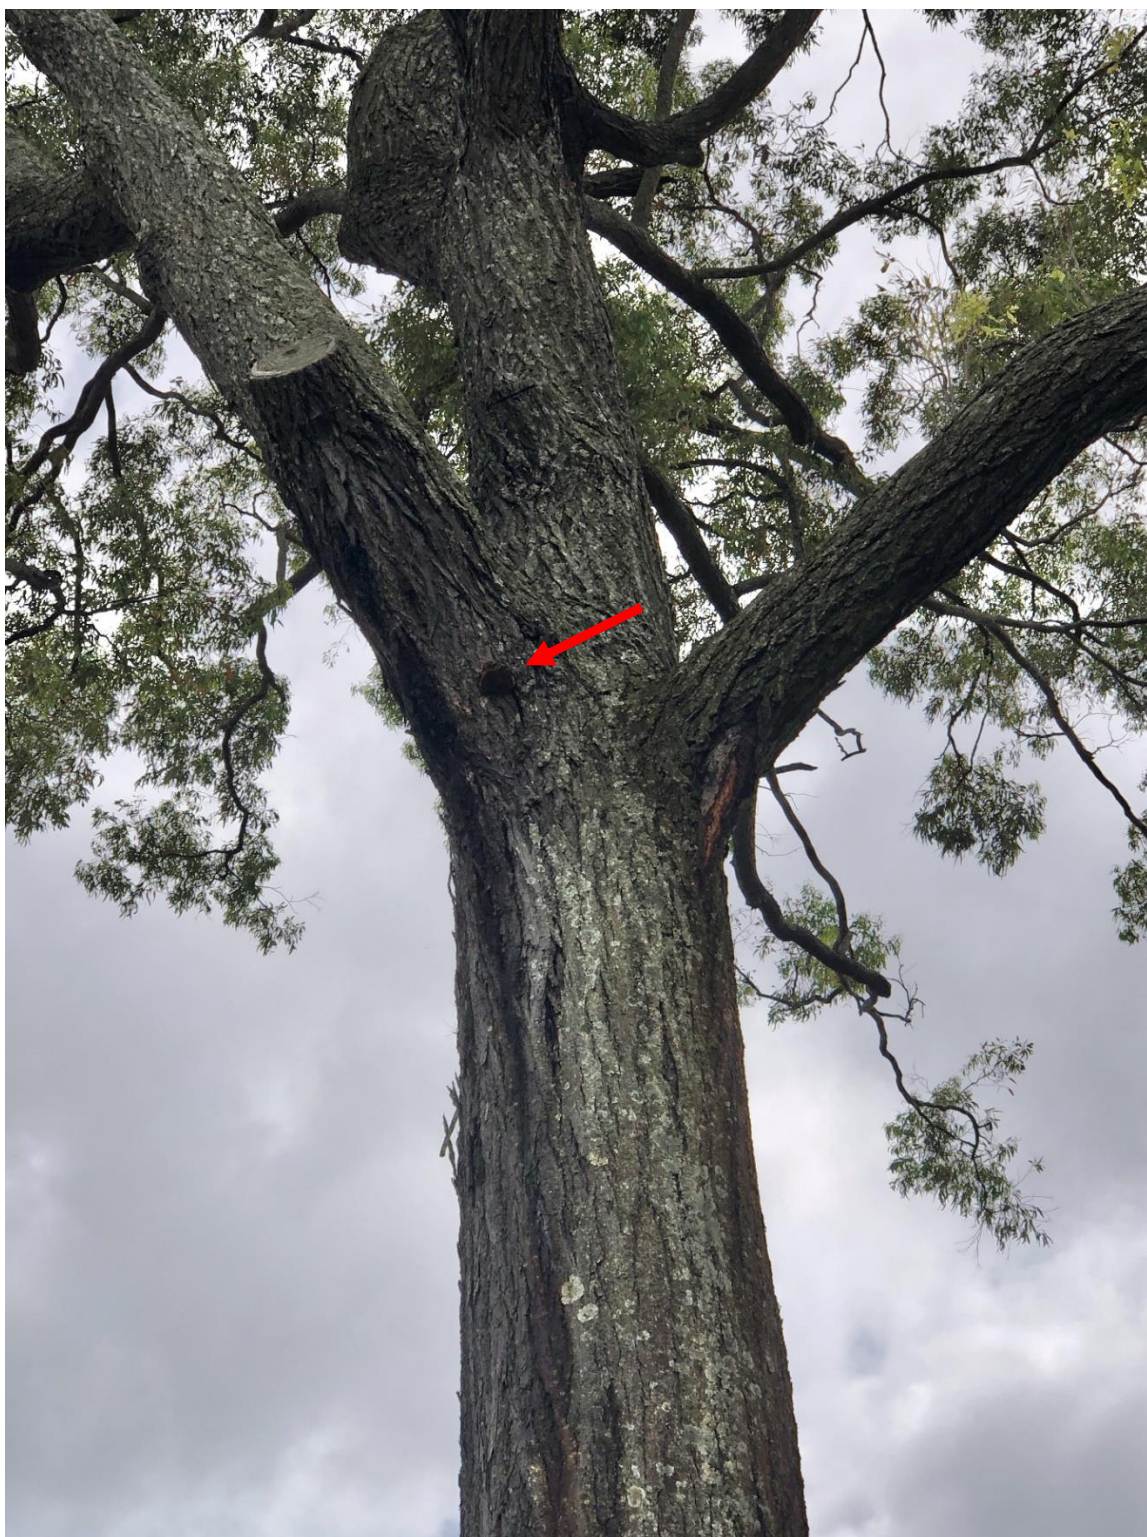
*Plate 2: Image showing a second fruiting body (red arrow) near the first order limb. P. Vezgoff.*

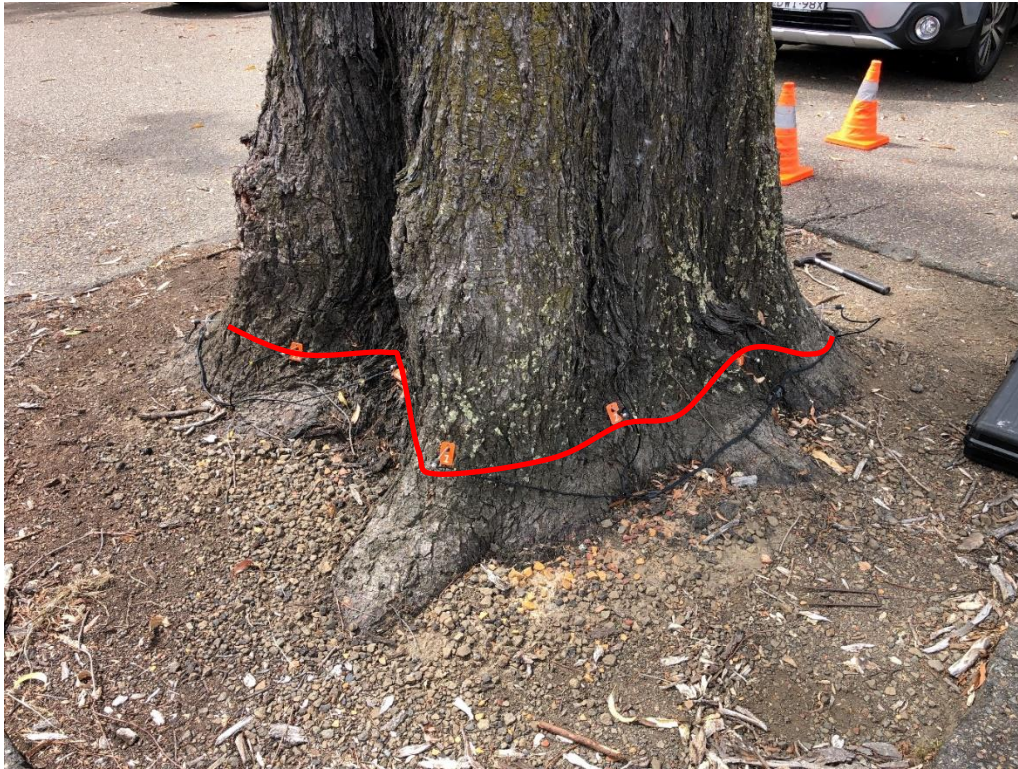
*Plate 3: North side of test area. Red line is the approximate location of the test. P. Vezgoff.*

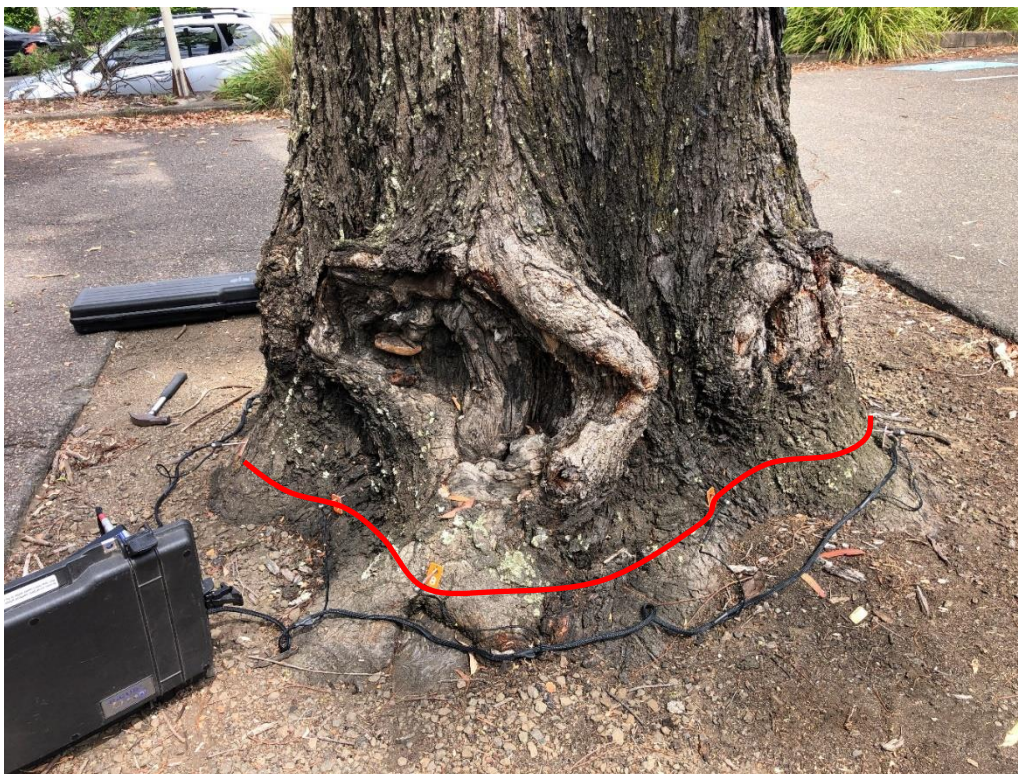
*Plate 4: South side of test area. Red line is the approximate location of the test. P. Vezgoff.*

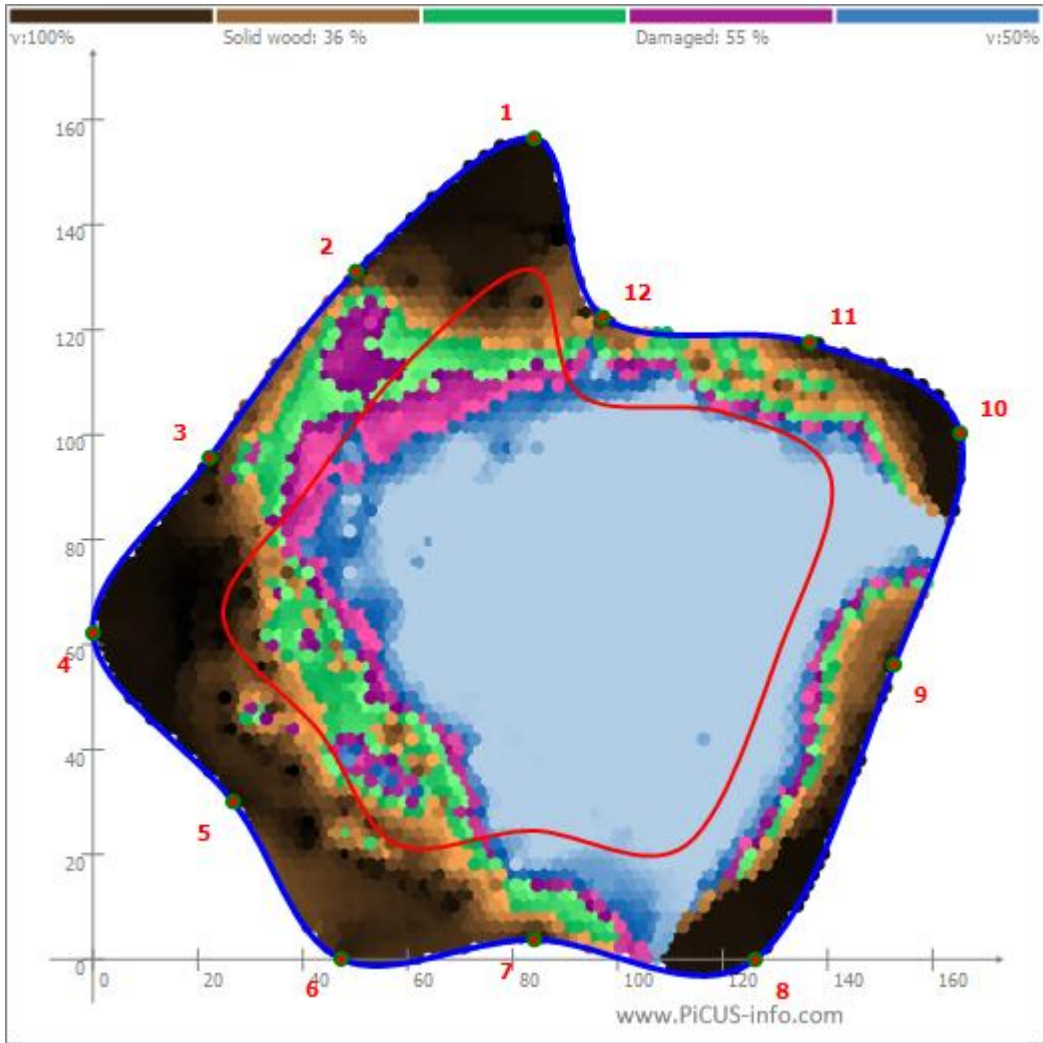
The test results show that the tree has 36% sound wood at the test location and 55% is showing as damaged wood (Plate 5).

**Plate 5:** Tomogram of the test location. Sensor 1 is north. The red line is indicative of the 70/30 ratio taken as a radial measurement from the centre of the trunk to each sensor. The area of damaged wood has reached the t/R limit of the red line.

- 1) The subject tree has stem wounds and shows evidence of decay within these wounds.
- 2) The subject tree is in fair health.
- 3) The subject tree is not exposed to new wind forces that it has not been in the past.
- 4) The subject tree has 36% sound wood at the test location.
- 5) The subject tree will not recover from this extent of decay being present.
- 6) The target area would be considered a high use area for long parts of the day and week.
- 7) A secondary fruiting body is located further up the trunk.

The subject tree is becoming structurally compromised at the base. It is unlikely an area of decay this large will compartmentalize completely due to the extent of decay involved. Due to the decay being within the basal area it is also possible that the roots of this tree have been affected by the decay fungi. Due to the element of risk that this tree could fail at the root plate or main stem, I have recommended this tree be removed.
