# Picus Sonic Tomograph Test Report

## Beecroft Village shops carpark

Hornsby Shire Council, PO Box 37, Hornsby NSW 1630

February 2023

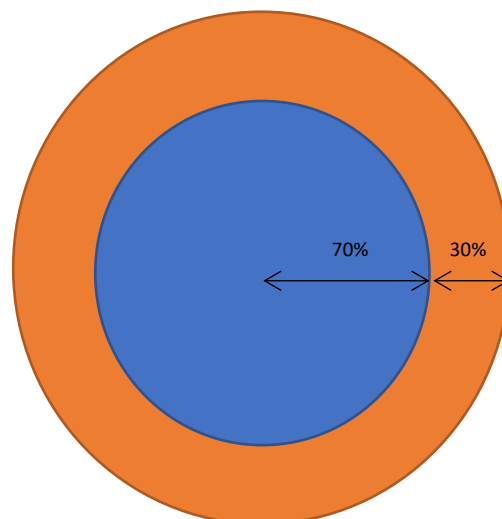
Diagram A

Thus, if a tomogram reading is at 51% sound wood this will indicate that the sound wood quantity has reached the limit of 30% of the t/R ratio.
